PINTADO PISO ALMACÉN USUFRUCTO – MINA SPCC TOQUEPALA

Historical Track Record

PAINTED FLOOR STORE USUFRUCT – MINA SPCC TOQUEPALA

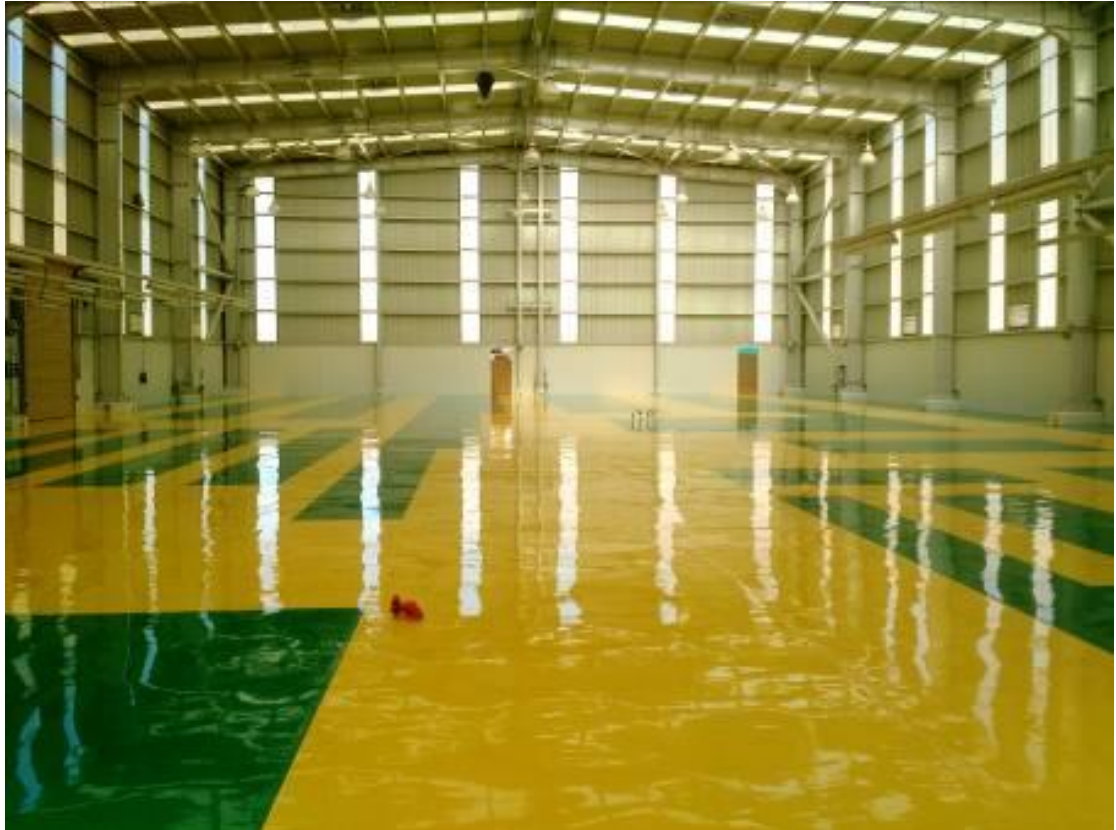
USUARIO FINAL	SPCC TOQUEPALA MINA	
CLIENTE	SPCC TOQUEPALA MINA	
CONTRATISTA	QROMA	
LUGAR / FECHA	Toquepala / Marzo 2015 – Mayo 2015	
PREPARACION DE SUPERFICIE	"Limpieza con equipos portátiles con chorro centrifugo - ShotBlaster", SSPC-SP13 con textura similar CSP-3.	
ZONA	PRODUCTO	ESPESOR SECO
Piso 1653 m2	Jet Pro Sealer	5.0 mils
	Jet Pro Sealer WBE	5.0 mils
	Jet Pro Epoxy	10.0 mils
	Jet Pro Epoxy	10.0 mils
	EPS Total	30.0 mils
OBSERVACIONES		
<ul style="list-style-type: none"> Las juntas se sellaron con Jet Patch Epoxy y Joint Seal Epoxy. No se contó con disponibilidad del área al 100%.

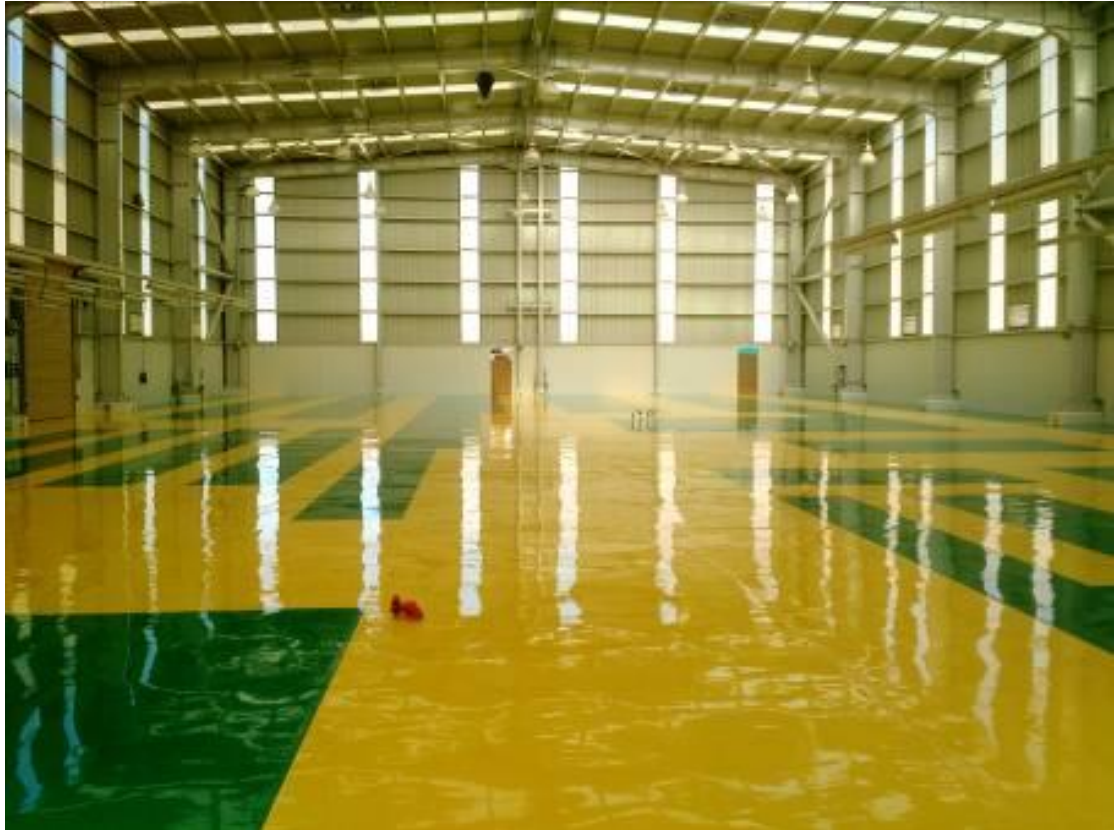
OWNER	SPCC TOQUEPALA MINA	
CUSTOMER	SPCC TOQUEPALA MINA	
CONTRACTOR	QROMA	
PLACE / DATE	Ilo / March 2015 – May 2015	
SURFACE PREPARATION	"Cleaning with laptops Centrifugal jet - ShotBlaster" SSPC-SP13 with similar texture CSP-3.	
ZONE	PRODUCT	DRY FILM THICKNESS
Floor 1653 m2	Jet Pro Sealer WBE	5.0 mils
	Jet Pro Sealer	5.0 mils
	Jet Pro Epoxy	10.0 mils
	Jet Pro Epoxy	10.0 mils
	DFT Total	30.0 mils
OBSERVATIONS		
<ul style="list-style-type: none"> ▪ The joints are sealed with Jet Patch Epoxy and Joint Seal Epoxy.. ▪ He did not count on the availability of 100% area.
